WATER QUALITY MEMORANDUM

Utah Coal Regulatory Program

RE: 2009 Fourth Quarter Water Monitoring, West Ridge Resources, West Ridge Mine, Task ID #3447

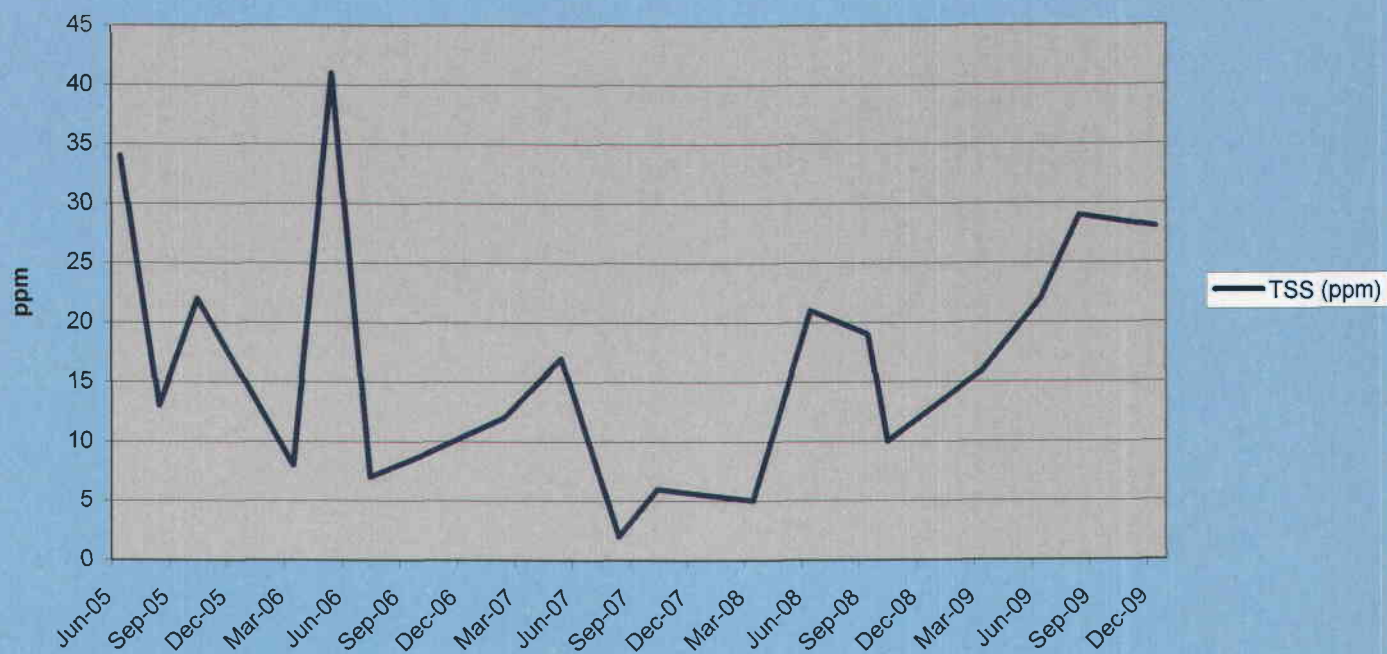
ST-5: TSS vs. Time

Flow values had been steadily rising at surface water monitoring site ST-5 until the 4th quarter of 2008. Since that time, the reported flow values have been decreasing erratically.

As the flow at this site is generated primarily from the mine-water discharge, particular attention has been paid to the TSS and T-Fe values. As discussed in detail below (UPDES Section), these two parameters have shown significant upward trends within the mine-water discharge. The reported TSS and T-Fe values for ST-5 this quarter decreased slightly. The cause for the fluctuations is unclear. The reported T-Fe value for site ST-5 this quarter is 0.733 ppm. The reported TSS value for site ST-5 this quarter is 28 ppm.

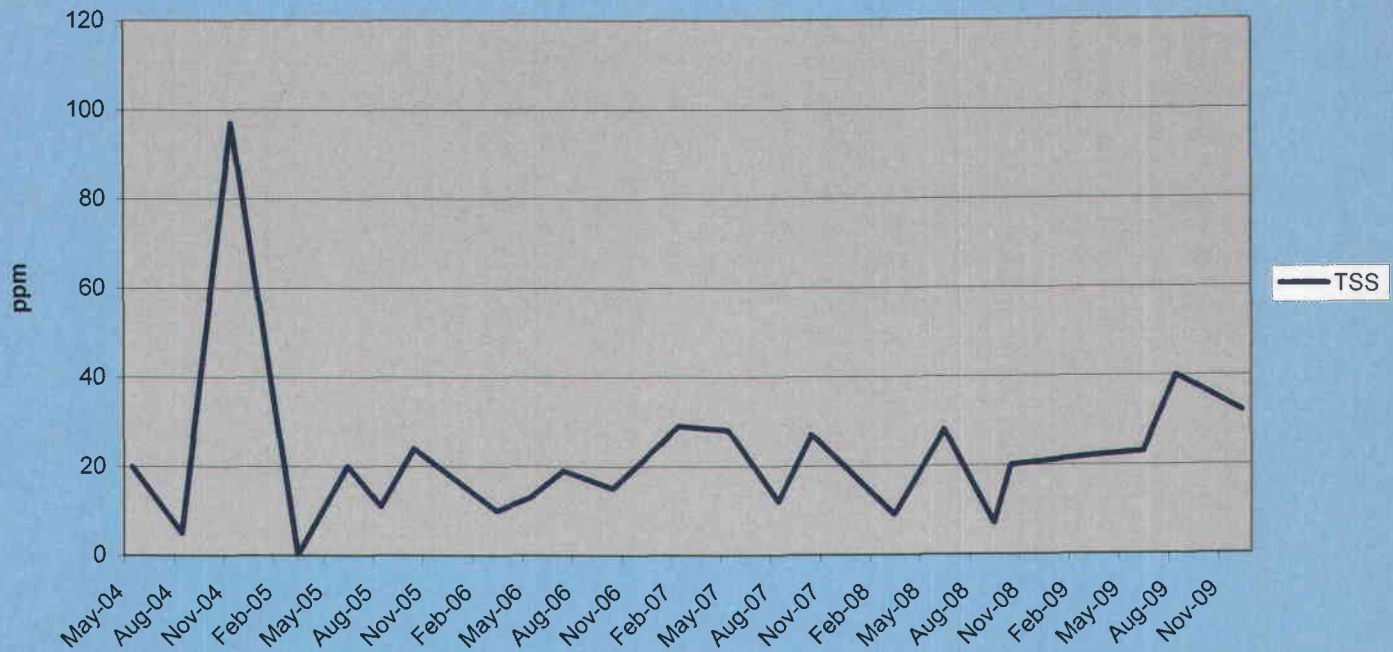
ST-6: TSS vs. Time

TSS levels had been steadily increasing at site ST-6 the previous 5 quarters. However, this quarter produced a TSS concentration of 32 ppm.

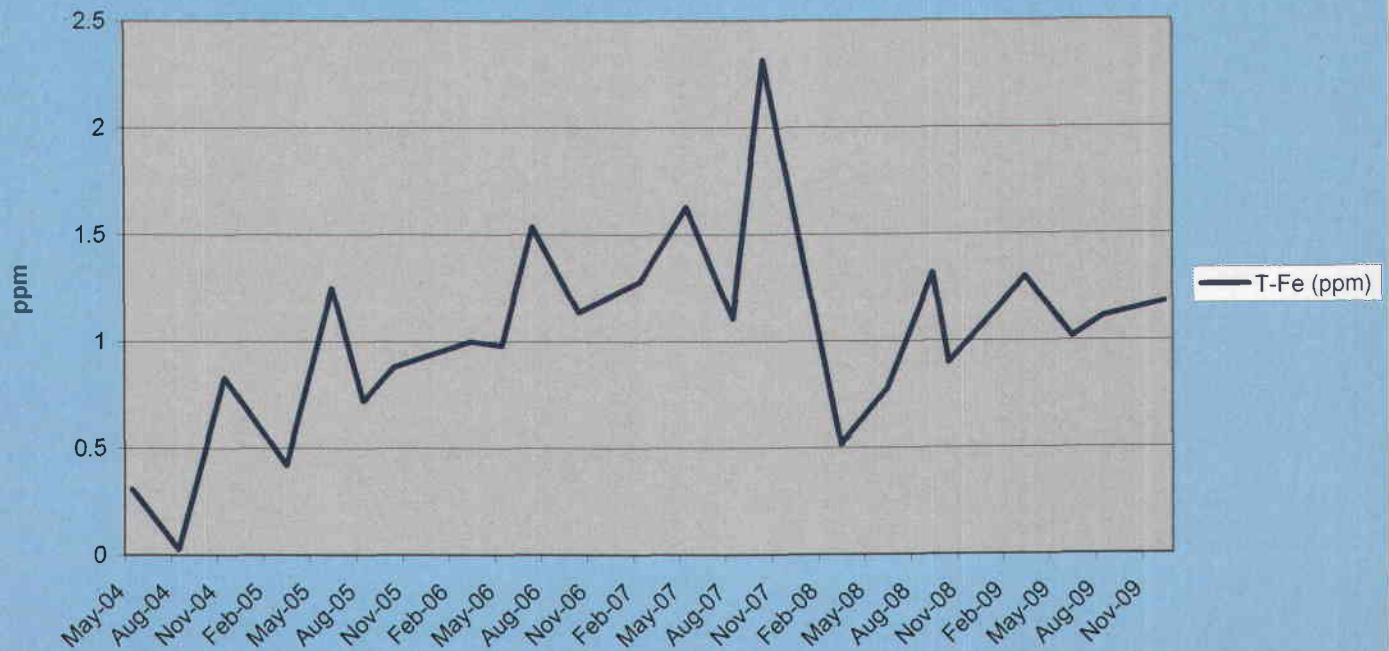
ST-6: T-Fe vs. Time

A non-compliant T-Fe value was reported during the 1st quarter of 2009 (1.301 ppm). Since that time, T-Fe concentrations at ST-6 have been relatively steady with reported values well within compliant levels as well as within two standard deviations from the mean.

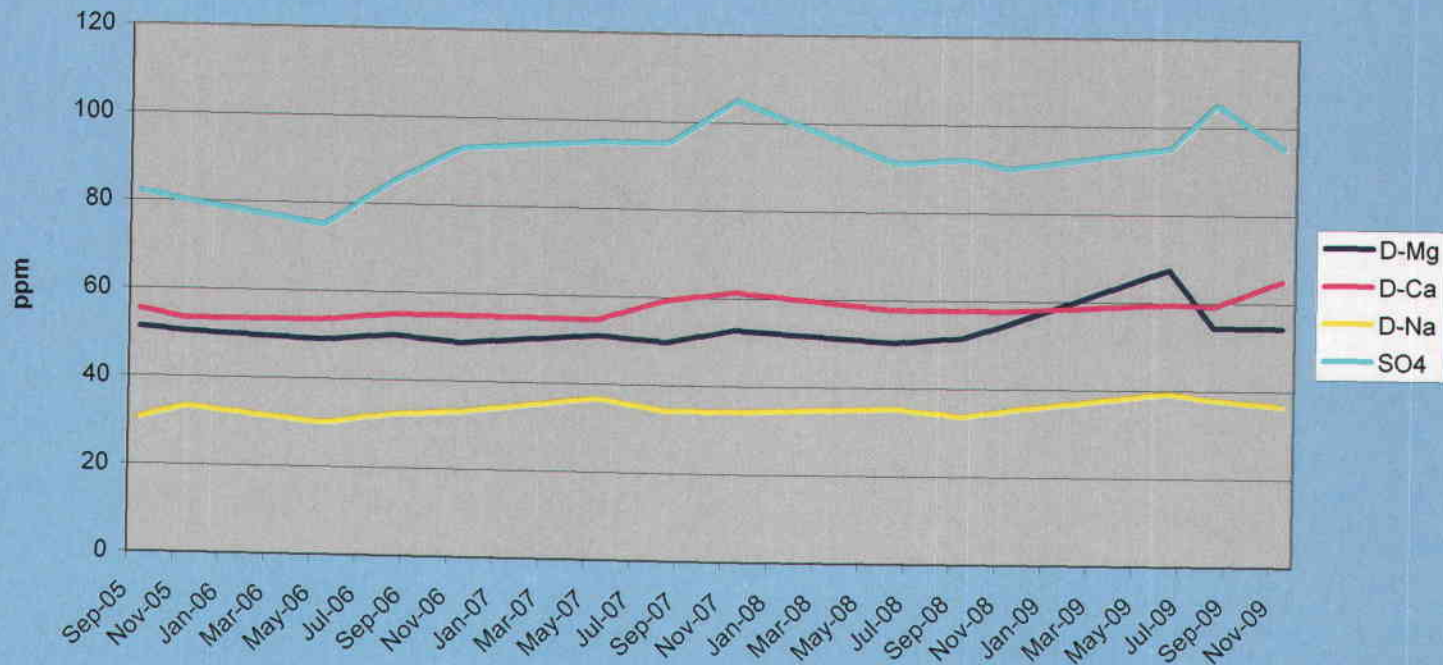
Spring SP-101

SP-101- For the last three consecutive quarters, this spring has begun to exhibit upward trends in several parameters. Continued monitoring will be conducted to determine what may be causing the upward trend.

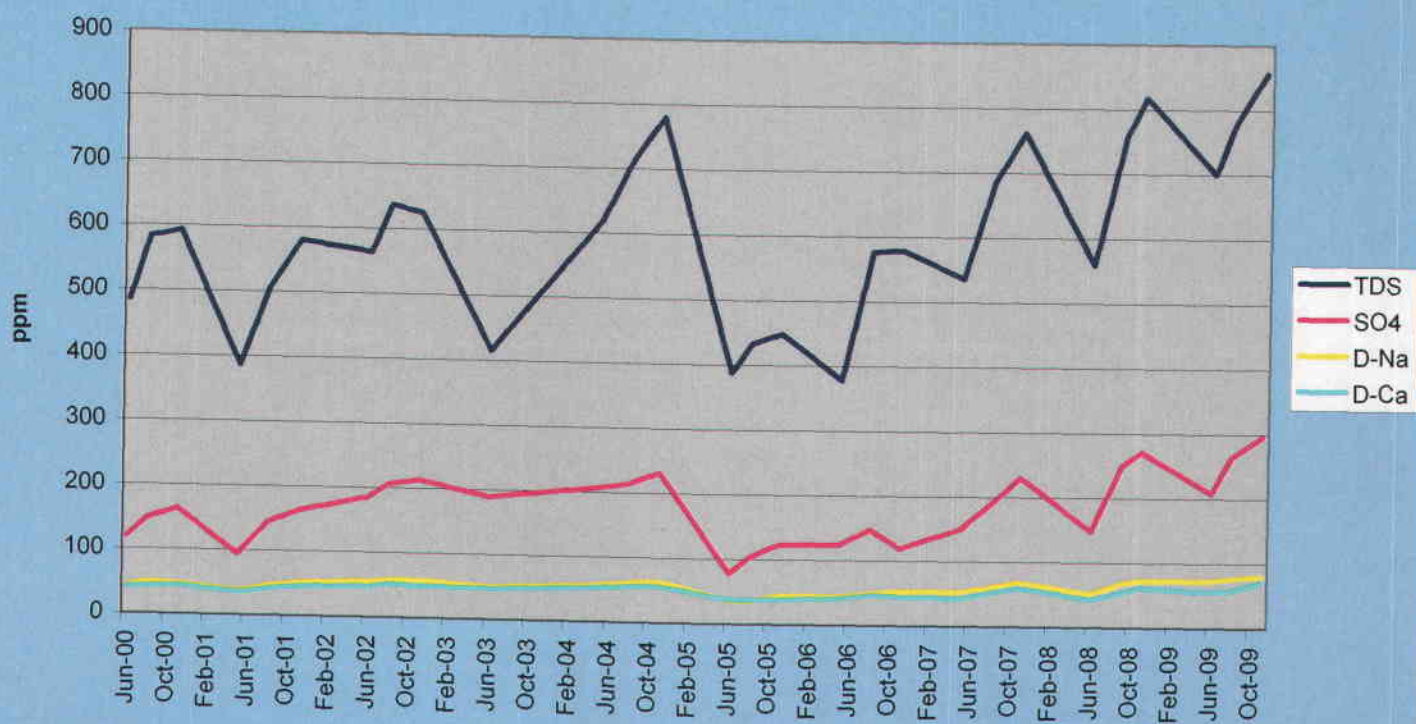
Spring SP-13

SP-13- This spring monitoring site continues to exhibit upward trends for TDS and SO₄. For the 3rd consecutive quarter, the site has reported values outside of two standard deviations from the mean.

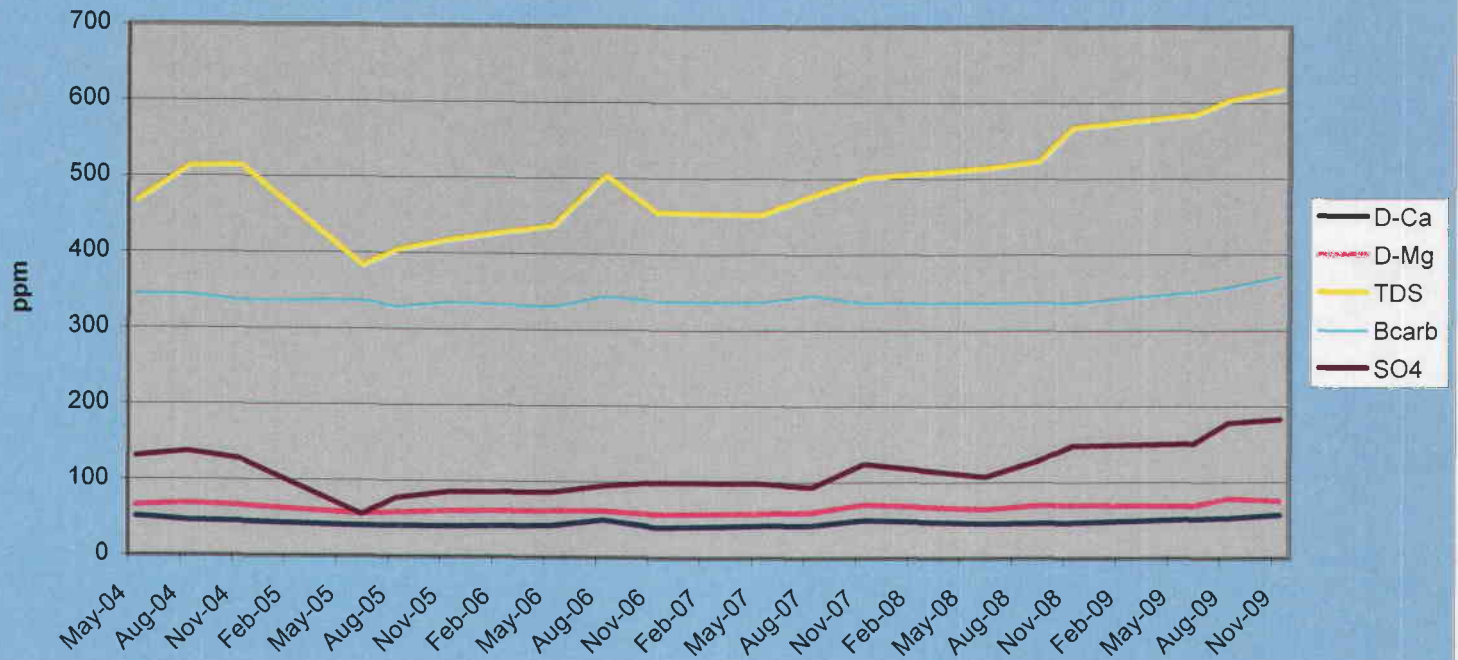
Spring SP-12

SP-12- Several parameters were again reported outside of two standard deviations for the third consecutive quarter (D-Ca, D-Mg, SO₄, TDS, Bicarbonate, Total-Cations and Total Anions).

It's unclear as to what's causing this spike. When weather/access conditions allow, a field inspection of the spring should be conducted if the current trend continues.

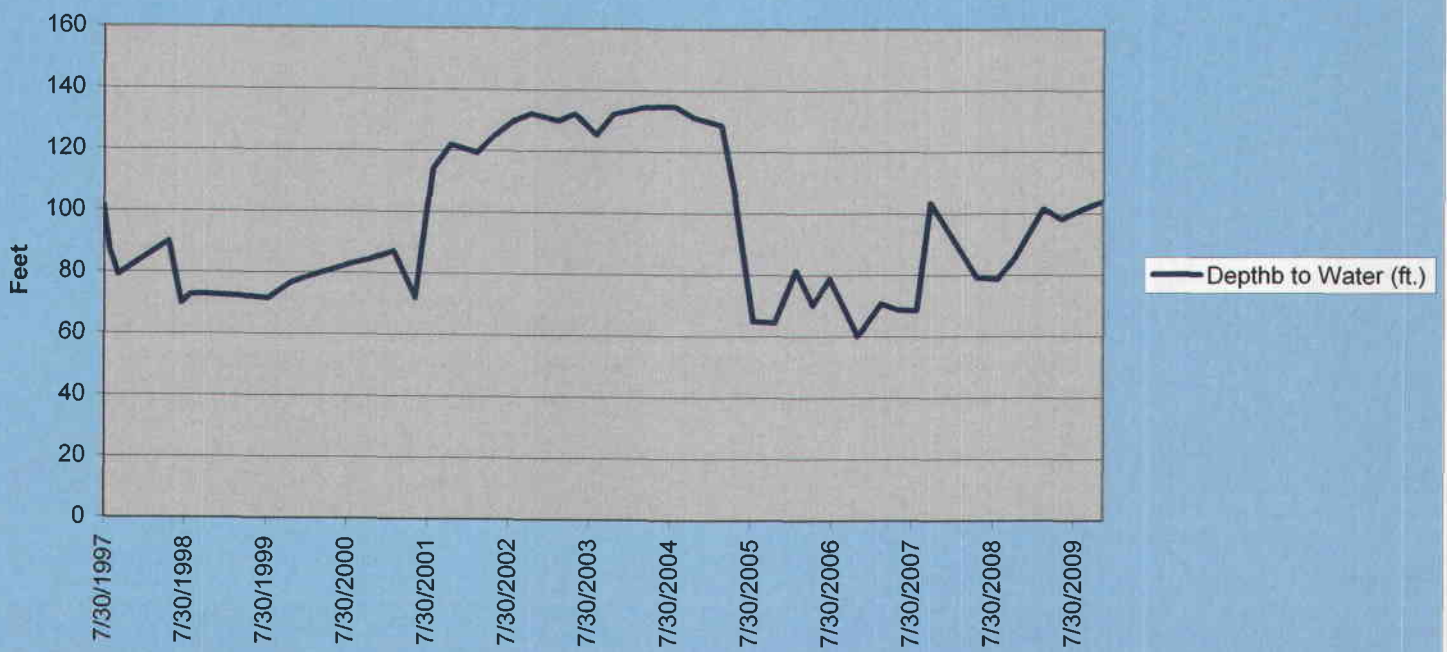
Monitoring Well DH 86-2 Several parameters were reported outside of two deviations for the previous quarter: D-K, Cl, T-Cats and T-Anions. All reported parameters were within two standard deviations of the mean for this quarter.

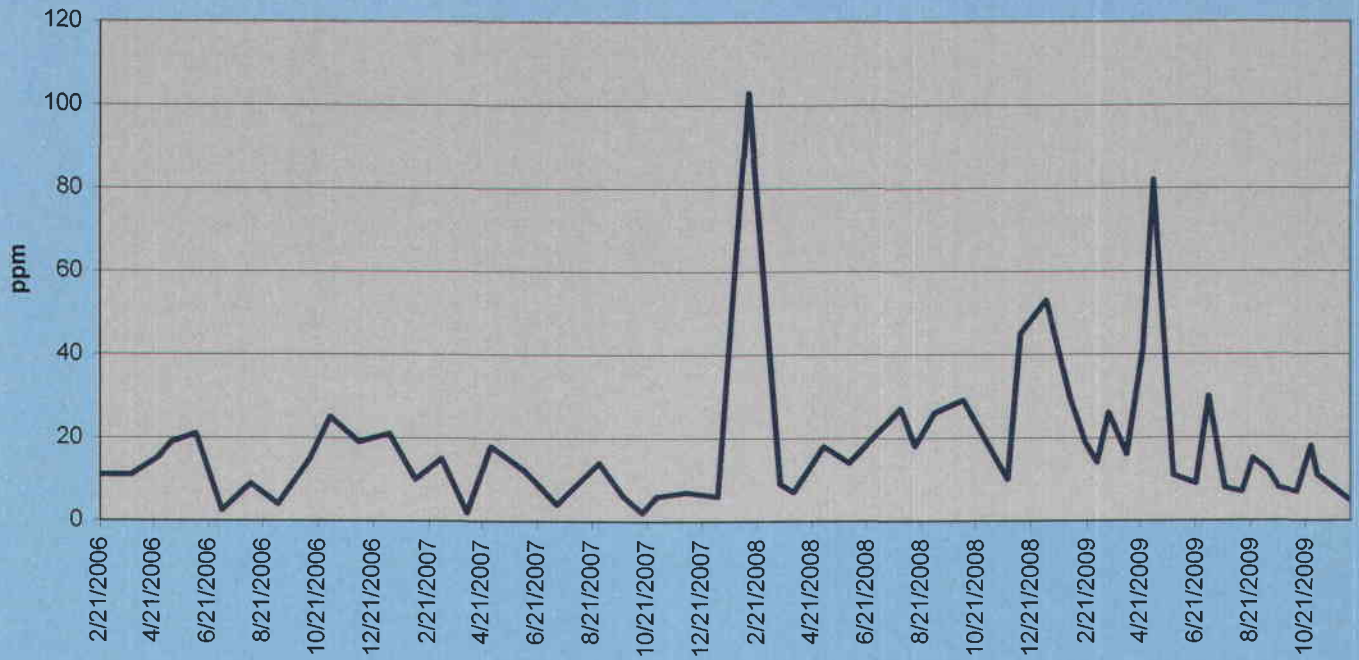
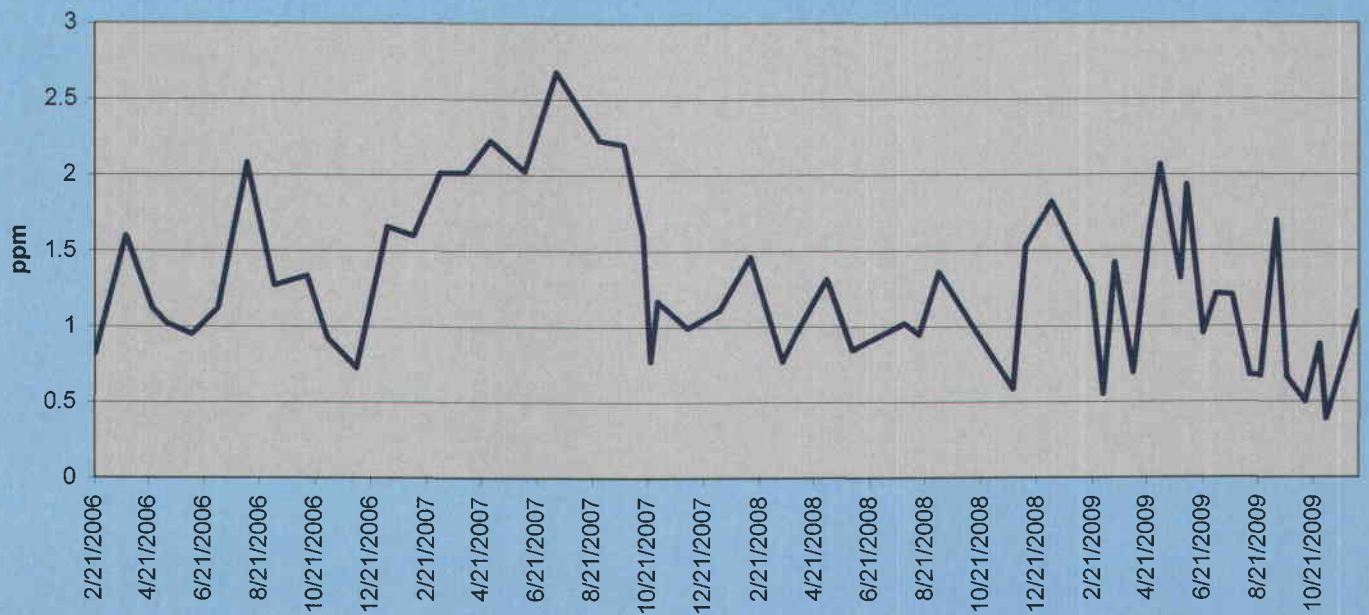
Site D002- UPDES Outfall 002 has exhibited fluctuating levels of TSS and T-Fe historically. However, based upon four sampling events this quarter, the reported values for both TSS and T-Fe were well within the compliance levels as established in their UPDES discharge permit (70 ppm and 1.3 ppm respectively).
